# BUILDING DEFECT INVESTIGATION REPORT

## External Timber Landscape / Planter Elements

**Report No:** QSEMS-BDI-001

Sample Gardens

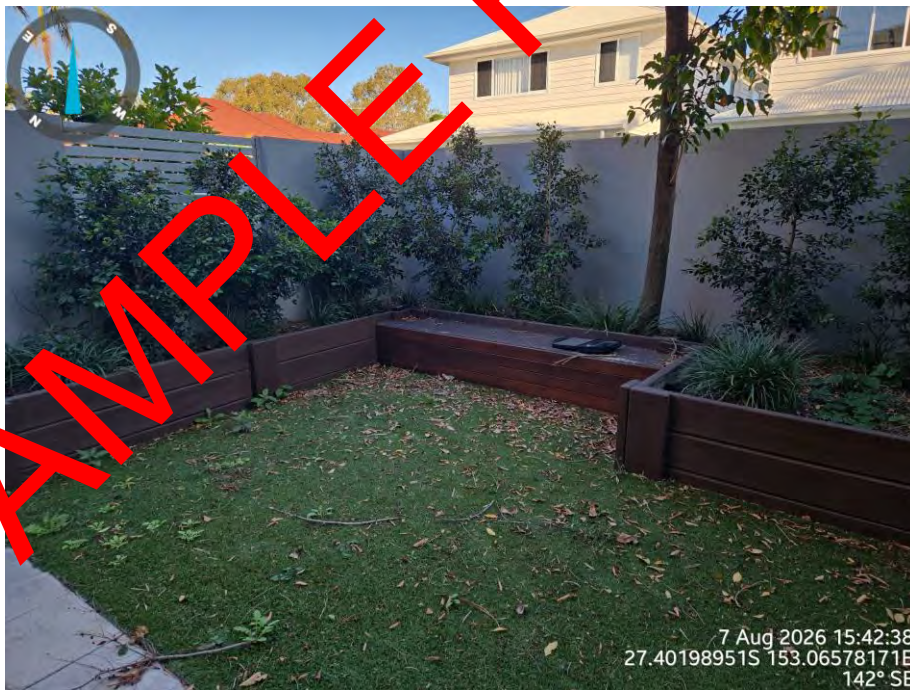
*General view of the external landscaped courtyard and timber planter/seal elements inspected.*

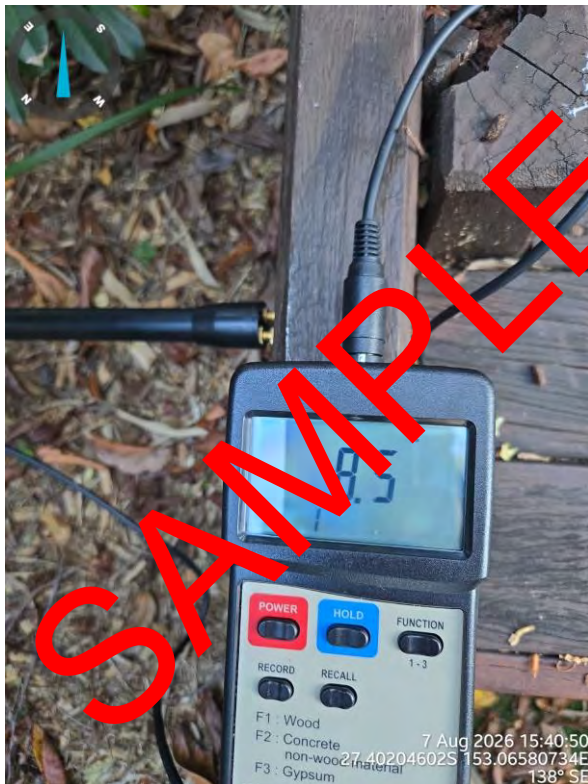
| Photo Ref. | Reading | Observation |
|---|---|---|
| P01 | 8.5% | Accessible external timber surface |

P01 - Moisture reading of 8.5% to accessible external timber.

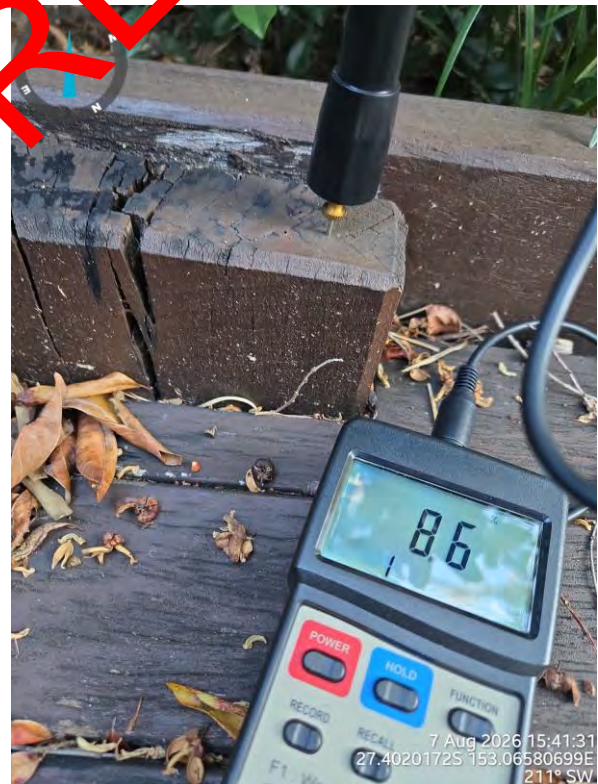
| Photo Ref. | Reading | Observation |
|---|---|---|
| P02 | 8.6% | Cracked top surface of timber post/block |

P02 - Moisture reading of 8.6% adjacent to visibly cracked timber.

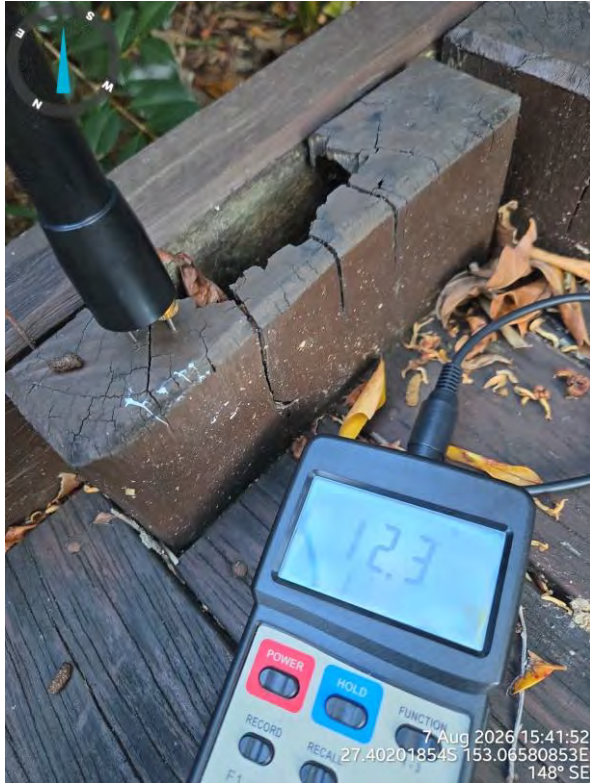
| Photo Ref. | Reading | Observation |
|---|---|---|
| P03 | 12.3% | Deteriorated/cracked timber member |

P03 - Moisture reading of 12.3% adjacent to deteriorated timber.

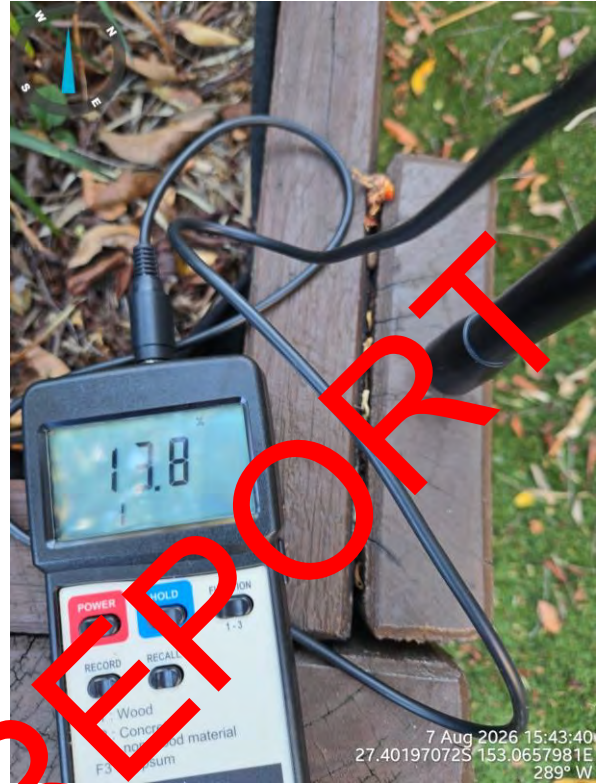
| Photo Ref. | Reading | Observation |
|---|---|---|
| P08 | 13.8% | Timber junction / top surface |

P04 - Moisture reading of 13.8% at an external timber junction.

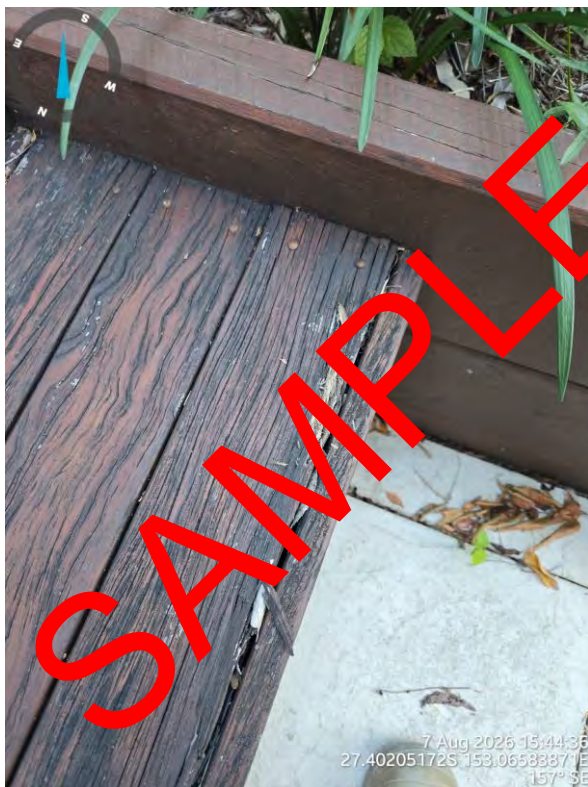
| <b>Inspector Description</b> | Localised timber decay and physical breakdown were observed to exposed timber elements, including areas where the surface and edge fibres have deteriorated and timber section has been lost. |
| <b>Potential Consequence</b> | Continued exposure may result in progressive decay, reduced durability, loosening of connected elements and increasing extent of replacement required. |

P12 - Close-up showing breakdown and loss of timber fibres at the edge of a horizontal member.

| <b>Recommended Action</b> | Remove and replace timber components where decay has materially reduced the sound timber section. Do not rely on cosmetic filling where the underlying timber is soft, friable or materially degraded. |

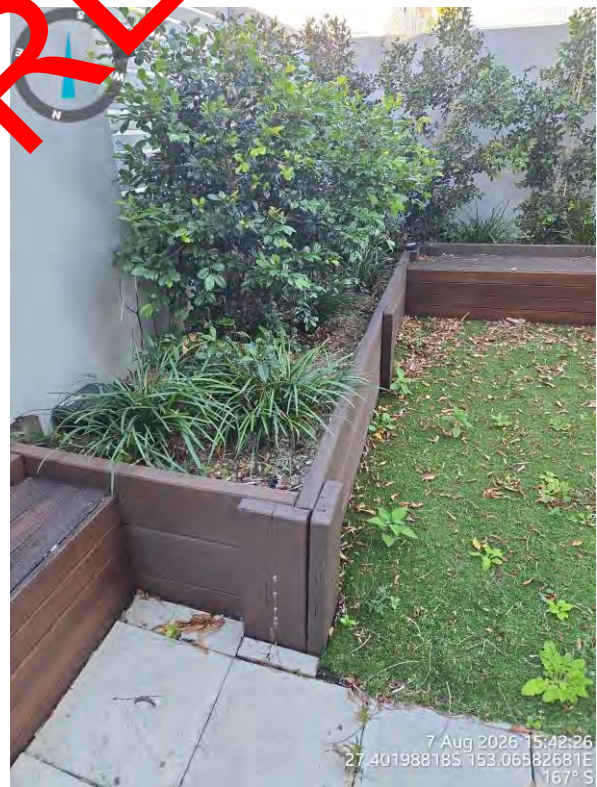
P05 - Cracked and deteriorated exposed top of timber post/block.

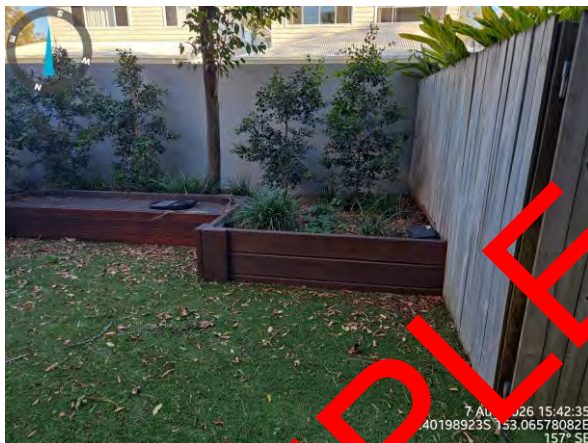
| <b>Inspector Description</b> | Extensive longitudinal checking and splitting were observed to multiple posts, blocks and horizontal members. Cracking is particularly evident at exposed end grain and top surfaces. |
| <b>Potential Consequence</b> | Open checks and splits provide pathways for water entry and can increase moisture retention within the timber, accelerating weathering and decay. |

P06 – General area of affected decay occurring .

| <b>Recommended Action</b> | Replace severely split or structurally compromised sections. Sound retained timber should be cleaned, allowed to dry, repaired where appropriate and fully recoated with a compatible exterior timber coating system, including exposed end grain. |

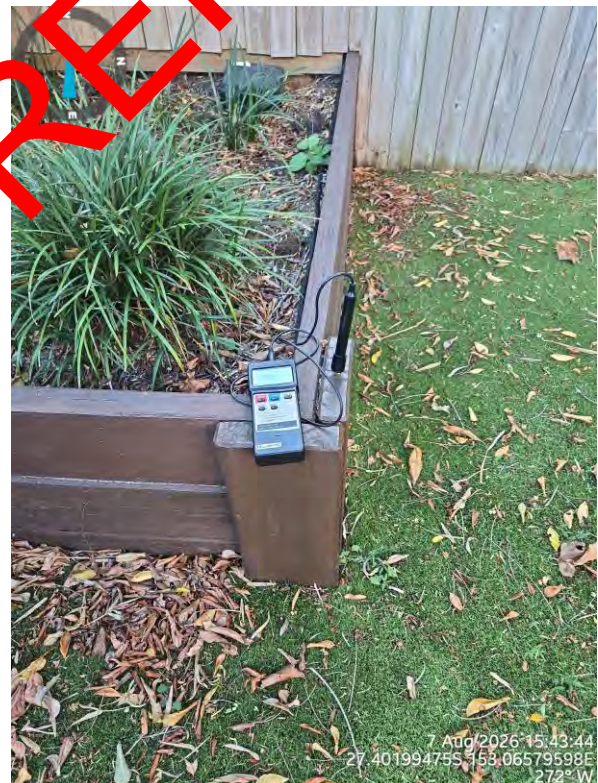
P09 - General close-up of cracked timber and open joint at the planter edge.

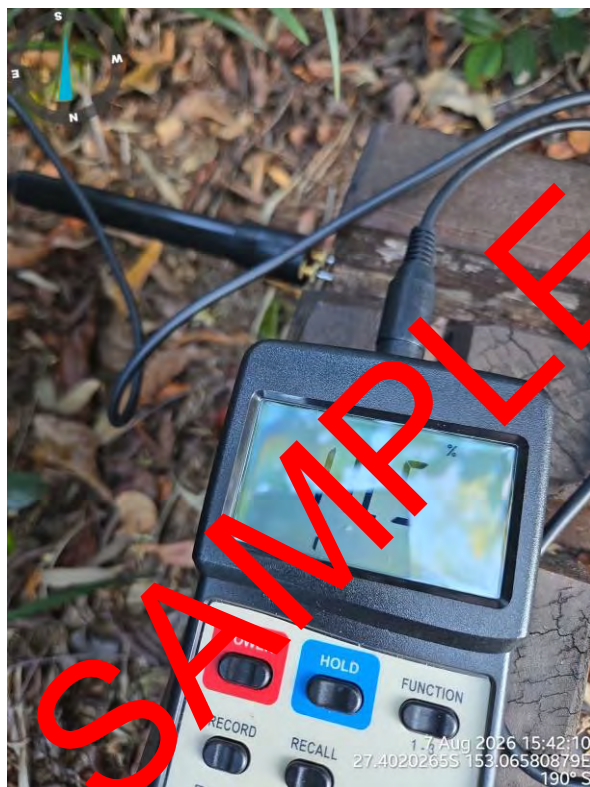
| <b>Inspector Description</b> | Several junctions comprise exposed horizontal top surfaces, exposed end grain and close-fitting interfaces between adjacent timber members. These locations can trap water and are slower to dry after rainfall or irrigation. |
| <b>Potential Consequence</b> | Repeated wetting and restricted drying can promote coating breakdown, checking and biological decay over time. |

P04 - Moisture testing adjacent to a cracked exposed timber junction.

| <b>Recommended Action</b> | During rectification, detail replacement timber to shed water and minimise horizontal water traps. Seal exposed end grain and cut ends before installation, maintain drainage/air gaps where practicable and apply a suitable exterior coating system to all exposed faces. |

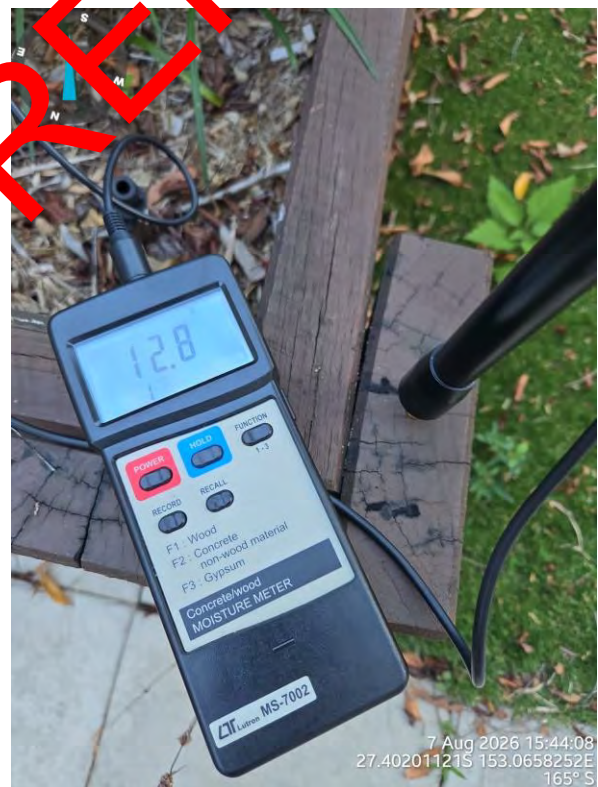
| Photo Ref. | Reading | Observation |
|---|---|---|
| P10 | 12.8% | Accessible timber surface |

P10 - Moisture reading of 12.8% with exposed horizontal and vertical timber interfaces visible.

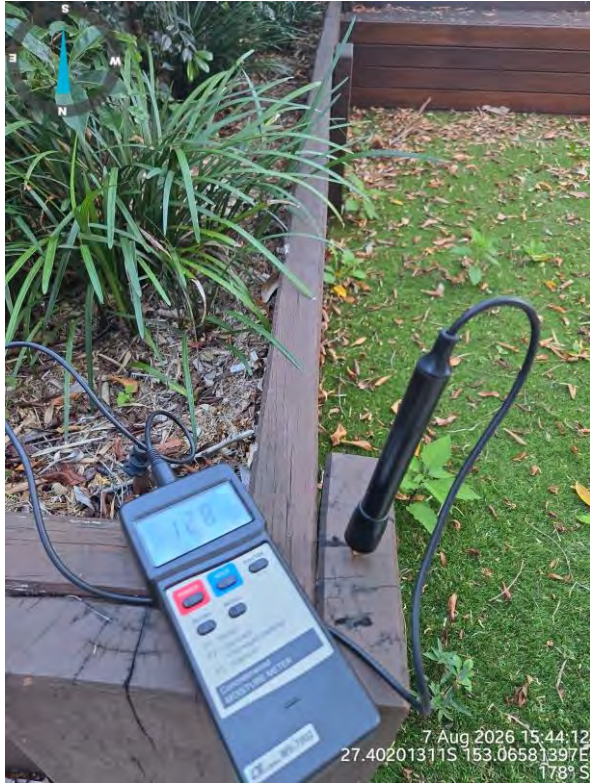
| Photo Ref. | Reading | Observation |
|---|---|---|
| P11 | 12.8% | Accessible timber surface |

| <b>Inspector Description</b> | The timber planter/seat and sleeper construction is located directly adjacent to landscaped garden beds, mulch, vegetation and ground surfaces. Leaf litter and organic material are also present around portions of the timber construction. No dedicated drainage outlet or drainage system was visible to the inspected face. It is noted that timber sleeper construction commonly incorporates joints and gaps between individual members that can permit incidental water passage and drying; however, the concealed drainage arrangement behind the wall was not visible and could not be verified. |
| <b>Potential Consequence</b> | Vegetation, mulch and debris can retain moisture against timber, obstruct inspection and reduce airflow and drying. Repeated environmental exposure, including rainfall and any nearby irrigation may contribute to deterioration over time. The absence of a visible drainage outlet is not, by itself, evidence of a drainage defect in this form of construction. |

*P11 - Moisture testing at a planter corner with garden bed immediately adjacent.*

| <b>Recommended Action</b> | Remove accumulated organic debris from timber interfaces, maintain separation between soil/mulch and susceptible timber where practicable, confirm irrigation is not discharging directly onto timber and keep available drainage paths and joints clear. If dismantling exposes evidence of retained water or ineffective concealed drainage, the drainage arrangement should then be reviewed and rectified as necessary. |

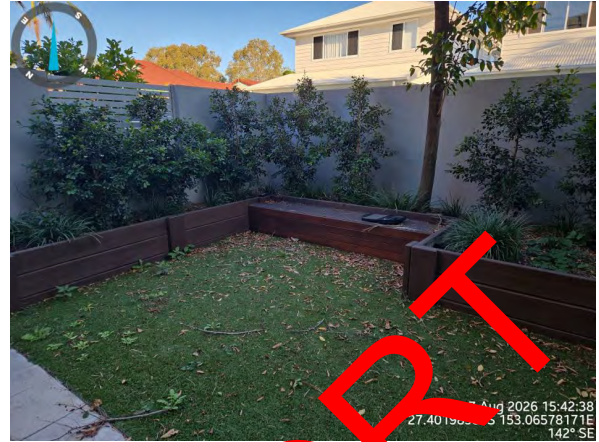
*P12 - General view showing timber planter/seat elements in close proximity to landscaped areas.*
